**Flood Control Project Maintenance
Levee Inspections**
LMA District Cover Sheet
Spring 2011 Levee Inspection Results

Brannan Andrus Levee Maintenance District

Waterway			Bank	Unit Miles
Unit No. 01 Georgiana Slough			Right	6.02
	Spring (March - May)	Summer (June - August)	(September - November) Fall	Winter (December - February)
Unit Maintenance Rating (Fall Only)				
Date of Inspection	4/20/2011 - 4/20/2011			
DWR Inspector	Richard Willoughby			
Accompanied By	Gil Labrie DCC Engineering

Levee Inspection Report By Mile - Spring 2011

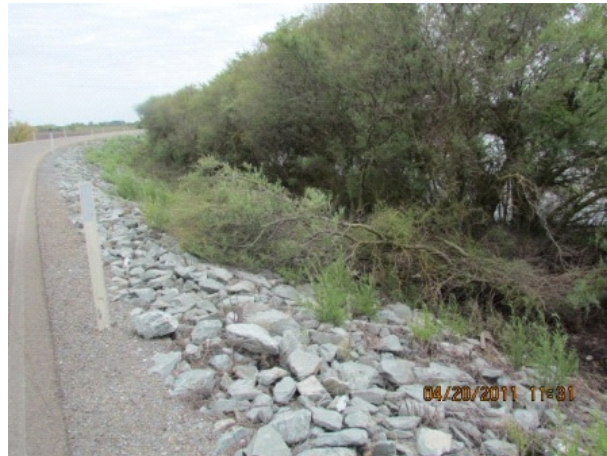
Levee Mile Report Line	8
Start Levee Mile	3.75
End Levee Mile	3.75
Location	Water Side
Category	Earthen Levee
Item	Encroachments

Looking northwest at down tree on waterside slope.

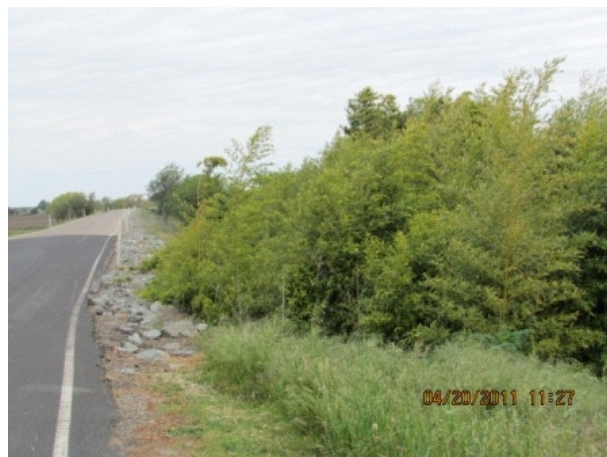
Levee Mile Report Line	9
Start Levee Mile	3.93
End Levee Mile	3.93
Location	Water Side
Category	Earthen Levee
Item	Vegetation

Looking west at dense vegetation on waterside slope.

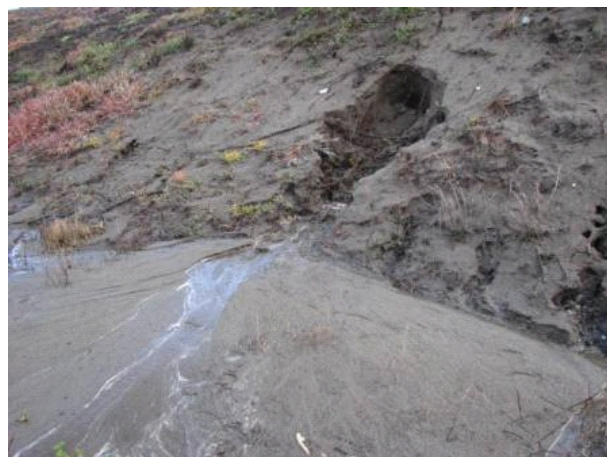
Levee Mile Report Line	14
Start Levee Mile	4.79
End Levee Mile	4.82
Location	Land Side
Category	Earthen Levee
Item	Seepage / Sandboils

Looking north on landside toe at one of several exist points of seepage.

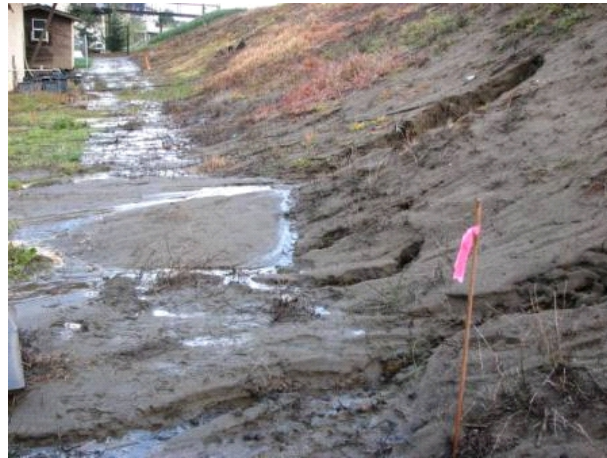
Levee Mile Report Line	14
Start Levee Mile	4.79
End Levee Mile	4.82
Location	Land Side
Category	Earthen Levee
Item	Seepage / Sandboils

Looking west along landside toe at several exist points of seepage.

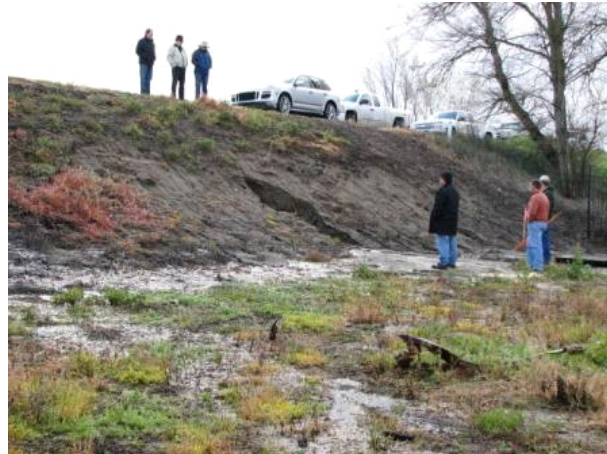
Levee Mile Report Line	14
Start Levee Mile	4.79
End Levee Mile	4.82
Location	Land Side
Category	Earthen Levee
Item	Seepage / Sandboils

Looking northeast at large sink hole on landside slope.

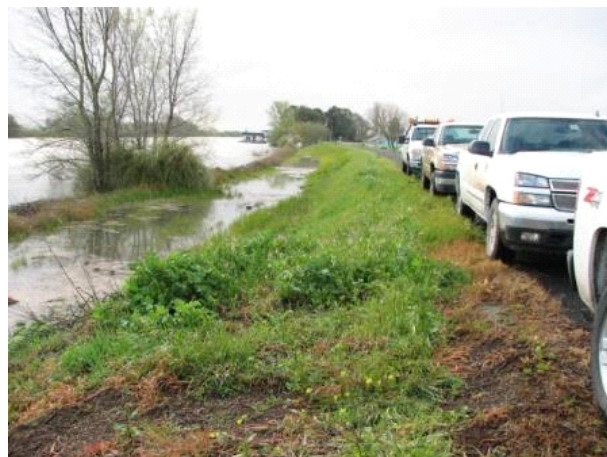
Levee Mile Report Line	14
Start Levee Mile	4.79
End Levee Mile	4.82
Location	Land Side
Category	Earthen Levee
Item	Seepage / Sandboils

Looking east at water on berm during inspection of seepage and sink holes.

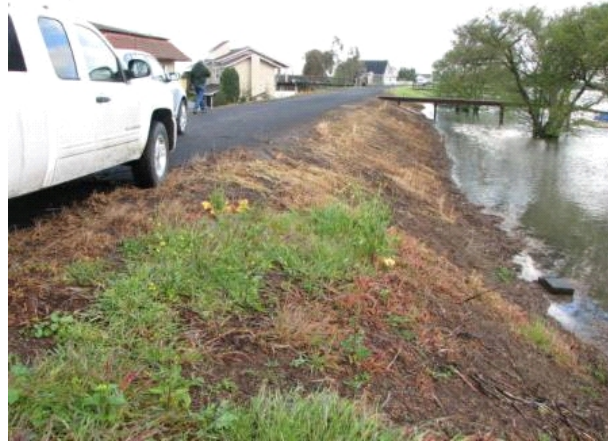
Levee Mile Report Line	14
Start Levee Mile	4.79
End Levee Mile	4.82
Location	Land Side
Category	Earthen Levee
Item	Seepage / Sandboils

Looking west at water on waterside toe during the inspection of seepage and sink holes.

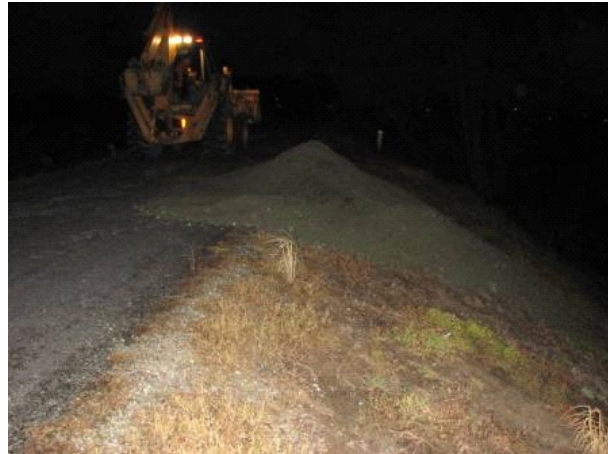
Levee Mile Report Line	14
Start Levee Mile	4.79
End Levee Mile	4.82
Location	Land Side
Category	Earthen Levee
Item	Seepage / Sandboils

Looking at first stage of repairs for seepage and sink holes on landside slope.

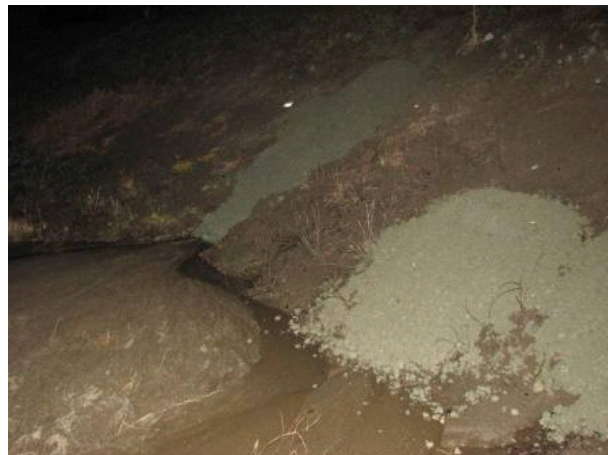
Levee Mile Report Line	14
Start Levee Mile	4.79
End Levee Mile	4.82
Location	Land Side
Category	Earthen Levee
Item	Seepage / Sandboils

Looking at one of two sink hole repairs on landside slope.

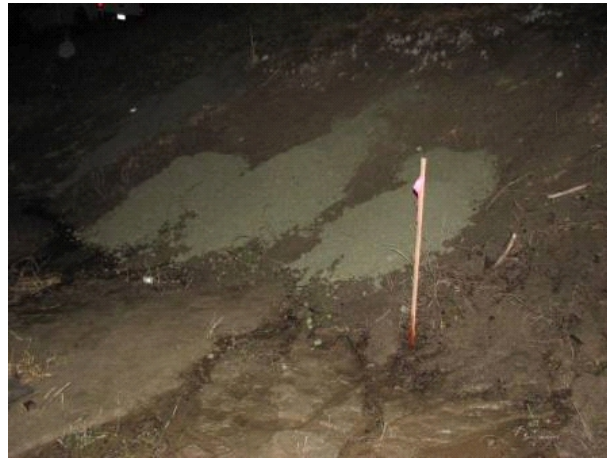
Levee Mile Report Line	14
Start Levee Mile	4.79
End Levee Mile	4.82
Location	Land Side
Category	Earthen Levee
Item	Seepage / Sandboils

Looking northwest at first stage of repairs for seepage on landside toe.

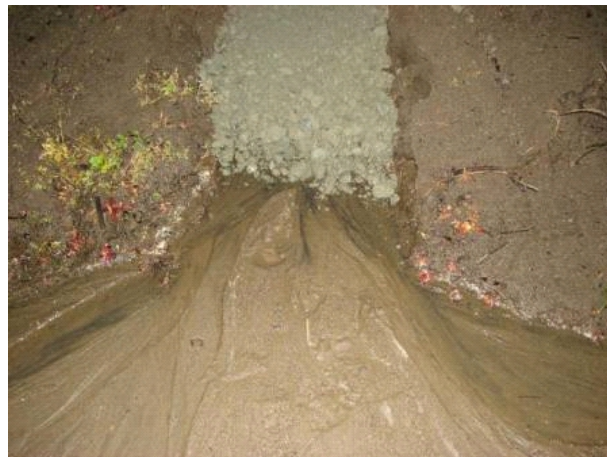
Levee Mile Report Line	14
Start Levee Mile	4.79
End Levee Mile	4.82
Location	Land Side
Category	Earthen Levee
Item	Seepage / Sandboils

Looking north at sink hole and the first stage of repairs to the site.

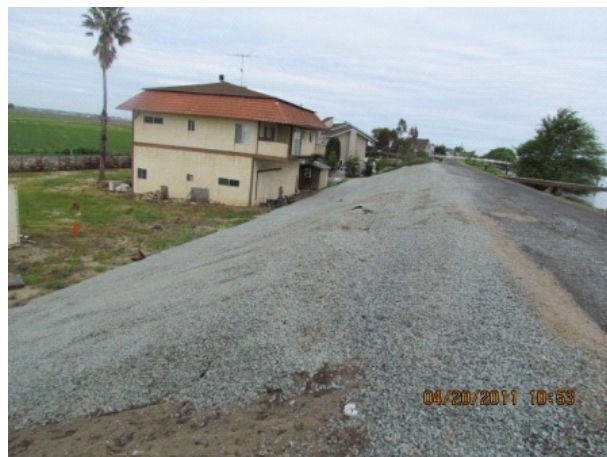
Levee Mile Report Line	14
Start Levee Mile	4.79
End Levee Mile	4.82
Location	Land Side
Category	Earthen Levee
Item	Seepage / Sandboils

Looking west at finish repair of sink holes and seepage with geo-tech fabric and drain rock.

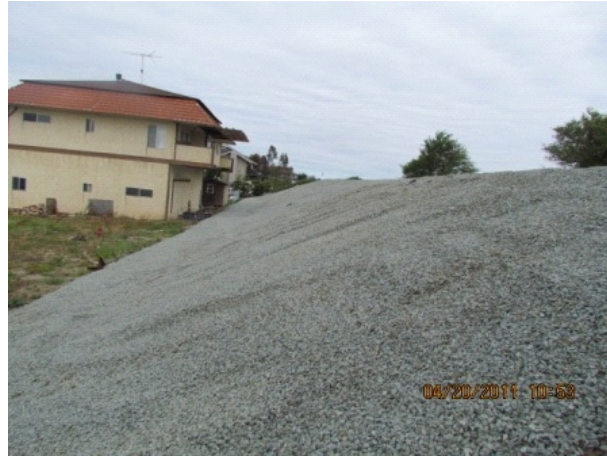
Levee Mile Report Line	14
Start Levee Mile	4.79
End Levee Mile	4.82
Location	Land Side
Category	Earthen Levee
Item	Seepage / Sandboils
Looking west at finish repair of seepage site on landside slope.	
richard_s_20110426_529.jpg

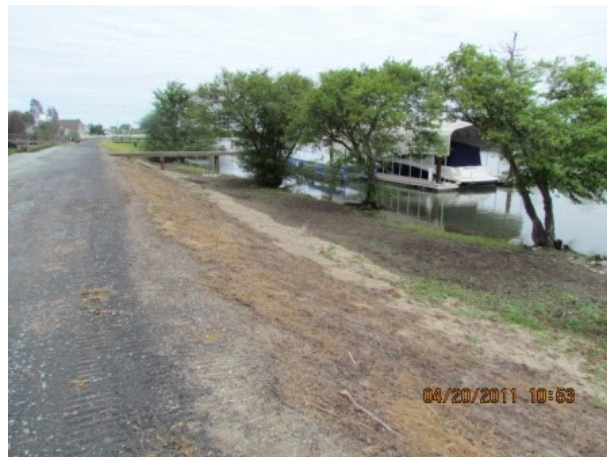
Levee Mile Report Line	14
Start Levee Mile	4.79
End Levee Mile	4.82
Location	Land Side
Category	Earthen Levee
Item	Seepage / Sandboils
Looking west at water level after final repair of seepage and sink holes site.	
richard_s_20110426_530.jpg

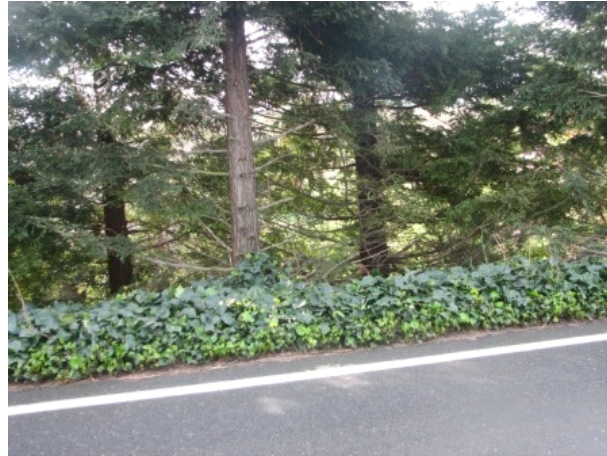
Levee Mile Report Line	6
Start Levee Mile	0.81
End Levee Mile	0.83
Location	Land Side
Category	Earthen Levee
Item	Encroachments
Landscaping on landside slope blocking view of slope from LM .81 to 0.83	
richard_s_20110215_001.jpg

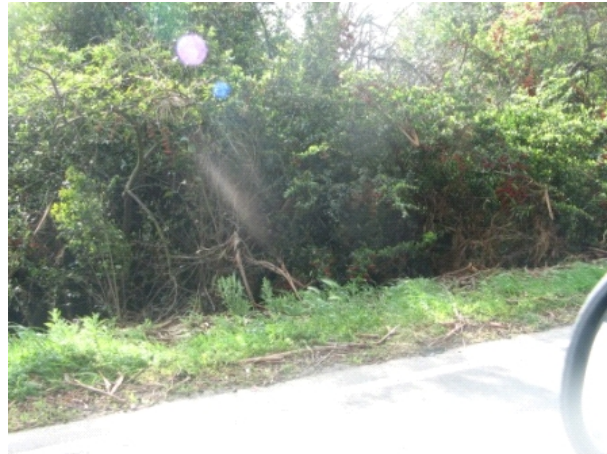
Levee Mile Report Line	11
Start Levee Mile	1.91
End Levee Mile	1.95
Location	Land Side
Category	Earthen Levee
Item	Encroachments
Landscaping on landside slope blocking view of slope from LM 1.91 to 1.95	
richard_s_20110215_002.jpg

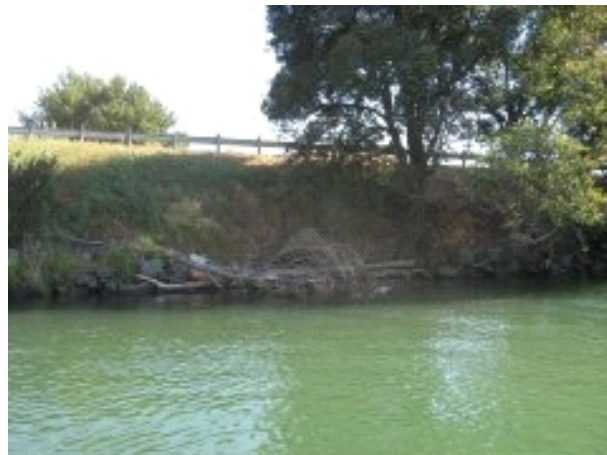
Levee Mile Report Line	13
Start Levee Mile	2.66
End Levee Mile	2.74
Location	Water Side
Category	Supplemental
Item	USACE Erosion Survey
2009: no berm, 1:1 slope, tree hazards, clays and silts, 3.81 ft/s [2009 SiteID:SAC_18-0_L]	
richard_s_20110215_003.JPG

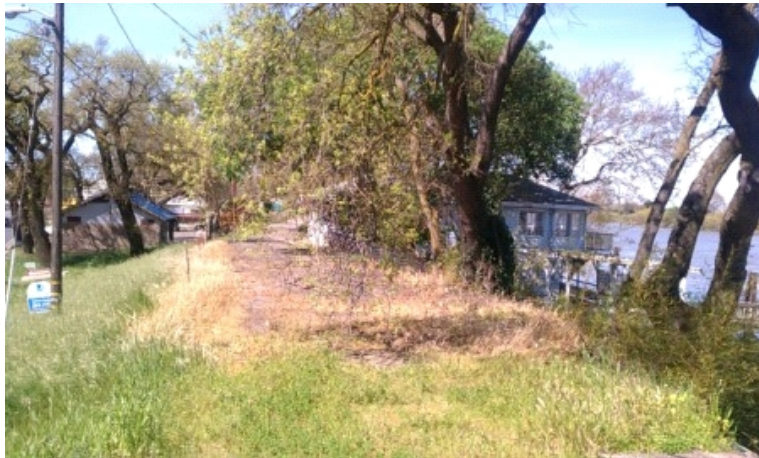
Levee Mile Report Line	15
Start Levee Mile	3.17
End Levee Mile	3.17
Location	Water Side
Category	Earthen Levee
Item	Trim / Thin Trees

Looking south at overhanging tree on waterside shoulder.

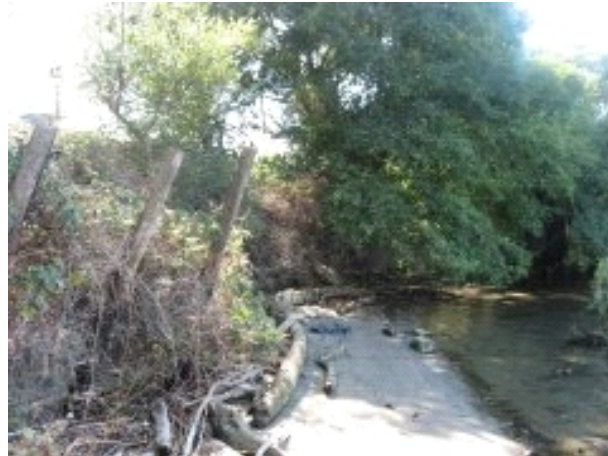
Levee Mile Report Line	18
Start Levee Mile	3.38
End Levee Mile	3.57
Location	Water Side
Category	Supplemental
Item	USACE Erosion Survey

2009: no berm, vertical slope, tension cracks, tree hazards, holes and slumping, silts, 3.43 ft/s [2009 SiteID:SAC_17-2_L]

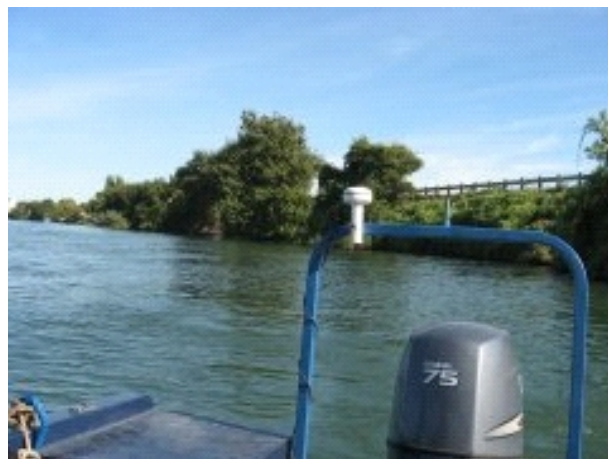
Levee Mile Report Line	20
Start Levee Mile	3.63
End Levee Mile	3.74
Location	Water Side
Category	Supplemental
Item	USACE Erosion Survey

2009: no berm, vertical slope, tension cracks, tree hazards, holes and slumping, silts, 3.22 ft/s [2009 SiteID:SAC_16-8_L]

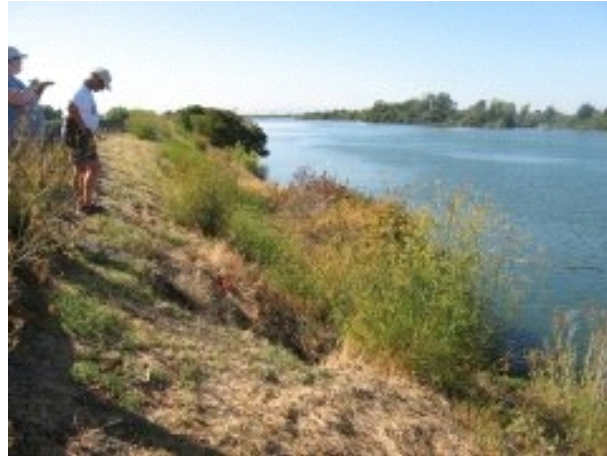
Levee Mile Report Line	28
Start Levee Mile	5.70
End Levee Mile	5.72
Location	Water Side
Category	Supplemental
Item	USACE Erosion Survey
2009: no berm, 1:1 slope, tension cracks and slumping, sands and cobbles, 2.82 ft/s [2009 SiteID:SAC_15-0_L]	
richard_s_20110215_006.JPG

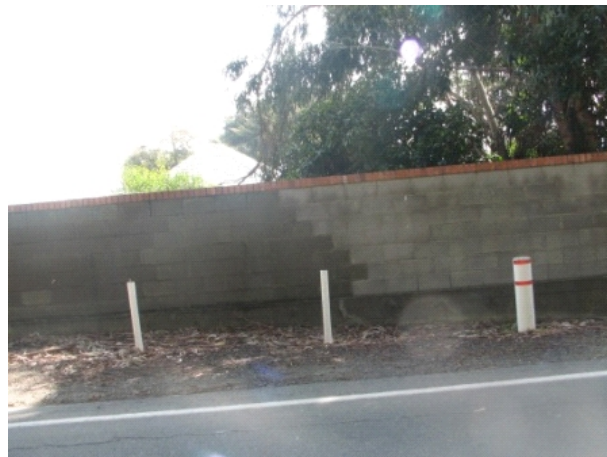
Levee Mile Report Line	31
Start Levee Mile	6.82
End Levee Mile	6.82
Location	Land Side
Category	Earthen Levee
Item	Encroachments
Brick wall on landside shoulder at LM 6.82	
richard_s_20110215_009.jpg

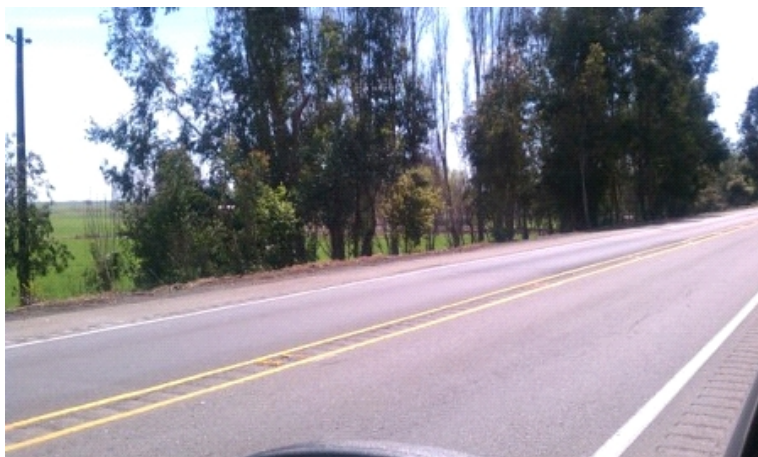
Levee Mile Report Line	32
Start Levee Mile	8.35
End Levee Mile	8.71
Location	Land Side
Category	Earthen Levee
Item	Trim / Thin Trees
Looking southeast at trees on landside shoulder and slope.	
richard_s_20110330_473.jpg

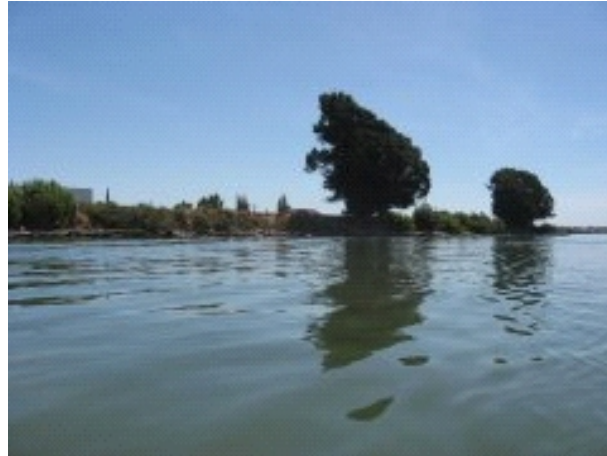
Levee Mile Report Line	34
Start Levee Mile	8.99
End Levee Mile	9.21
Location	Water Side
Category	Supplemental
Item	USACE Erosion Survey
2009: no berm, 1:1 slope, tree hazards, holes, and slumping, clays and silts, 6.8 ft/s [2009 SiteID:SAC_11-2_L] richard_s_20110215_007.JPG

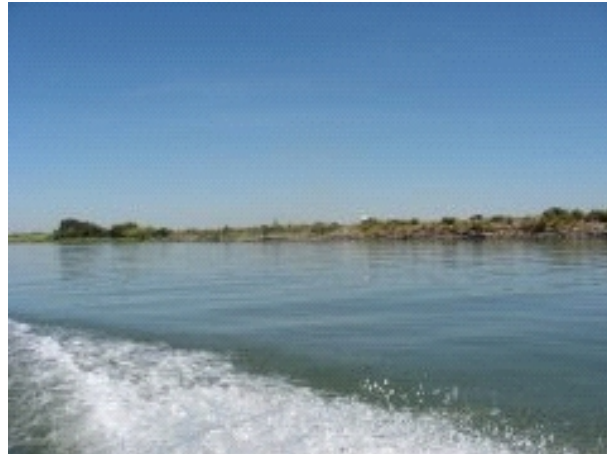
Levee Mile Report Line	37
Start Levee Mile	9.70
End Levee Mile	9.97
Location	Water Side
Category	Supplemental
Item	USACE Erosion Survey
2009: no berm, 1:1 slope, no stability issues, clays and silts, 7.05 ft/s [2009 SiteID:SAC_10-8_L] richard_s_20110215_008.JPG
